CLAY MOBILITY

PORTUGUESE BEND, CALIFORNIA

PAUL F. KERR and ISABELLA M. DREW

Scientific Report No. 1

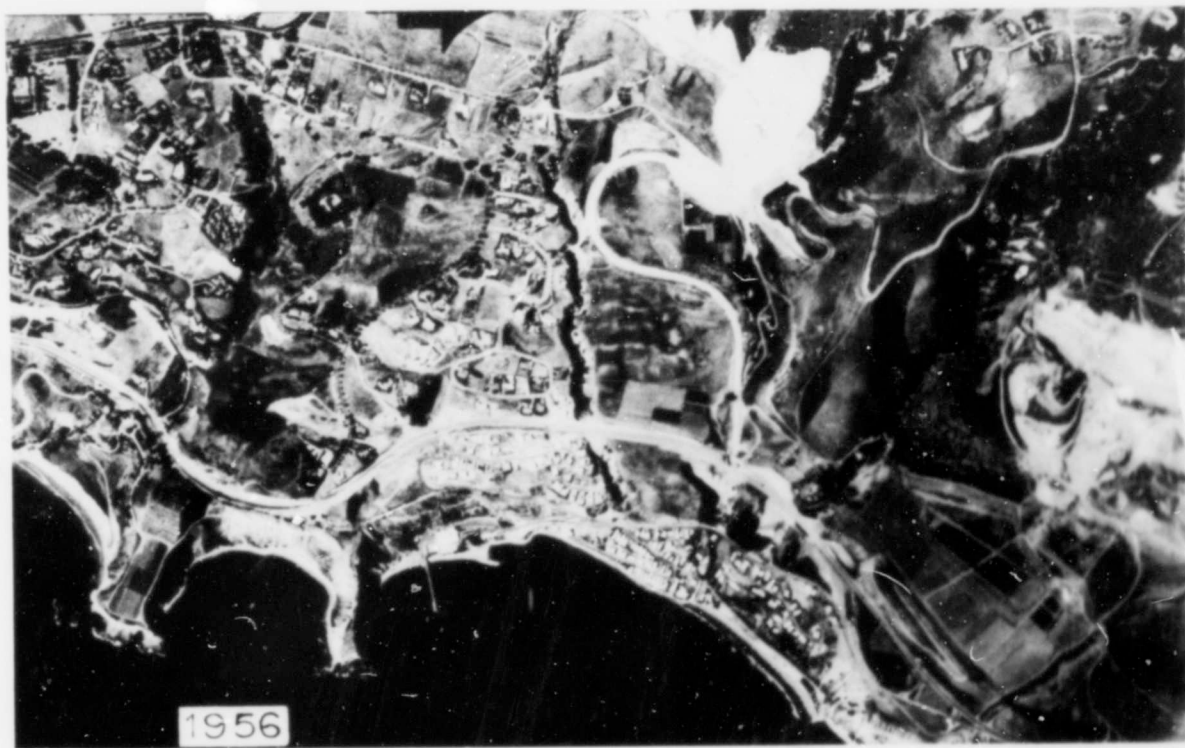
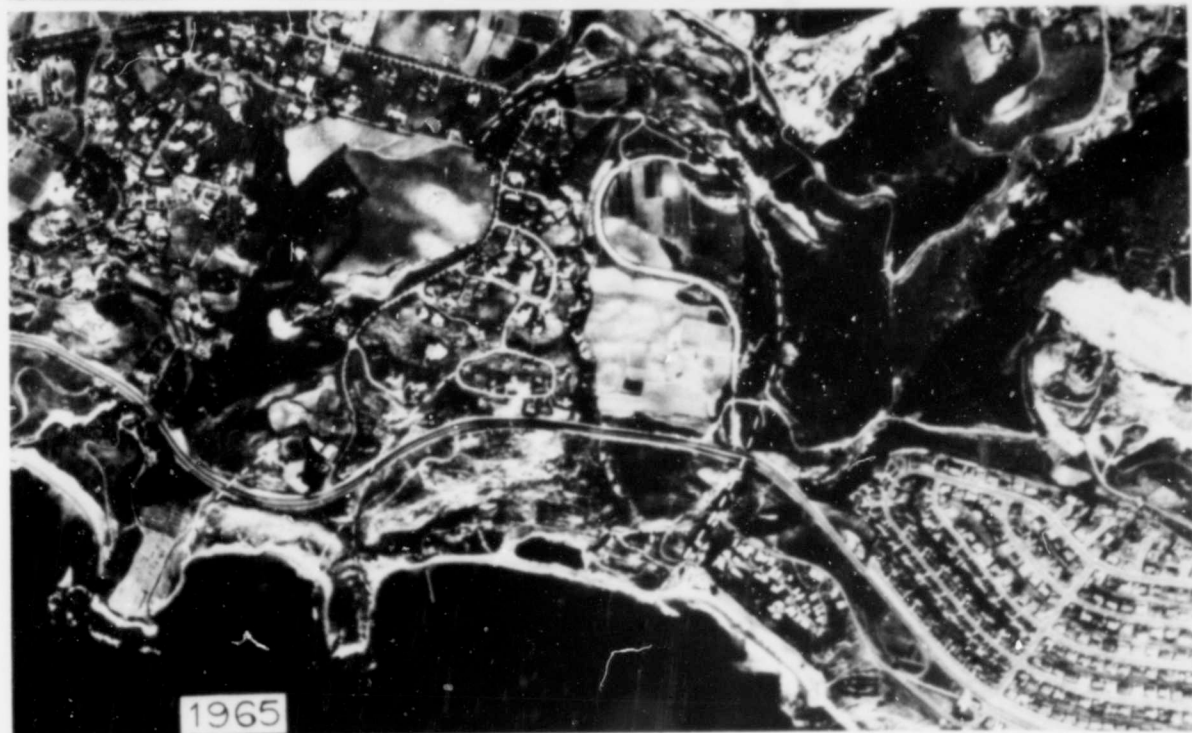
Plate 1

Aerial photographs of the same Portuguese Bend landslide area taken in 1956 and 1965. Note the absence of many houses between the highway and the shore in 1965. Dashed lines indicate approximate slide boundaries (1965).

Beginning in 1956, approximately one-fourth of the previously known landslide area became noticeably active (Pl. 1). Earthflow at the rate of 0.03 to 0.1 feet per day down a mean slope of 6.5° has continued since that time (Fig. 3). The cumulative effect of such slide action may be highly damaging in a residential area, but it is not immediately devastating. Motion differs greatly from such a slide as the 1950 quick clay slide at Surte, Sweden that moved on a slope of about 1° at a rate

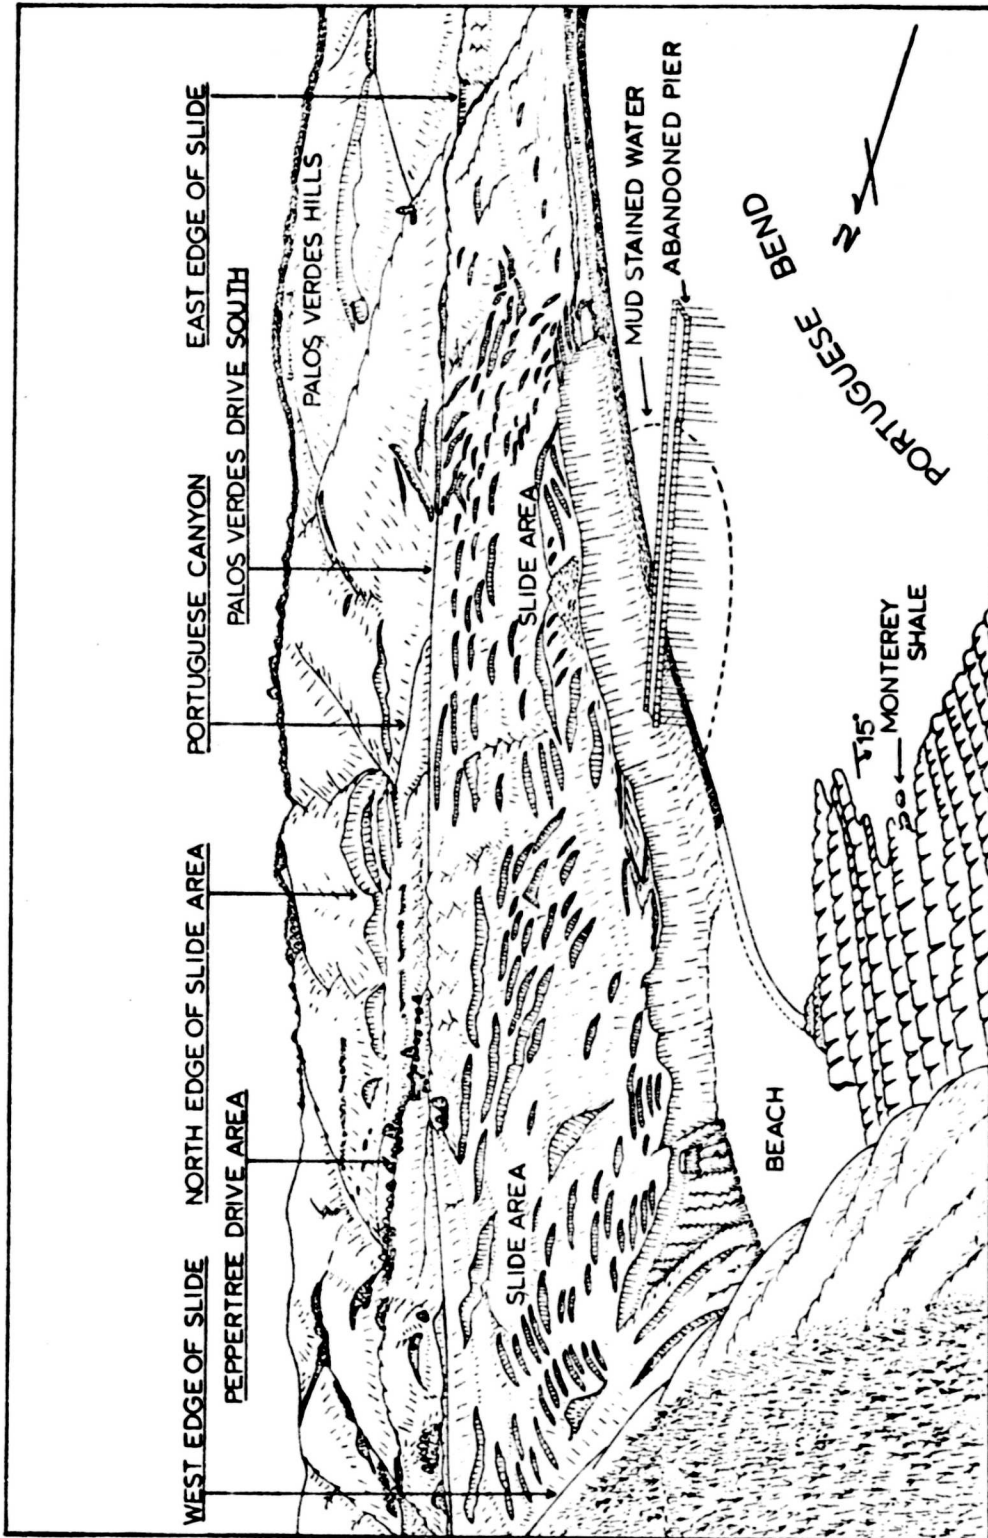
Fig. 2. A sketch of slide topography as observed in 1966.

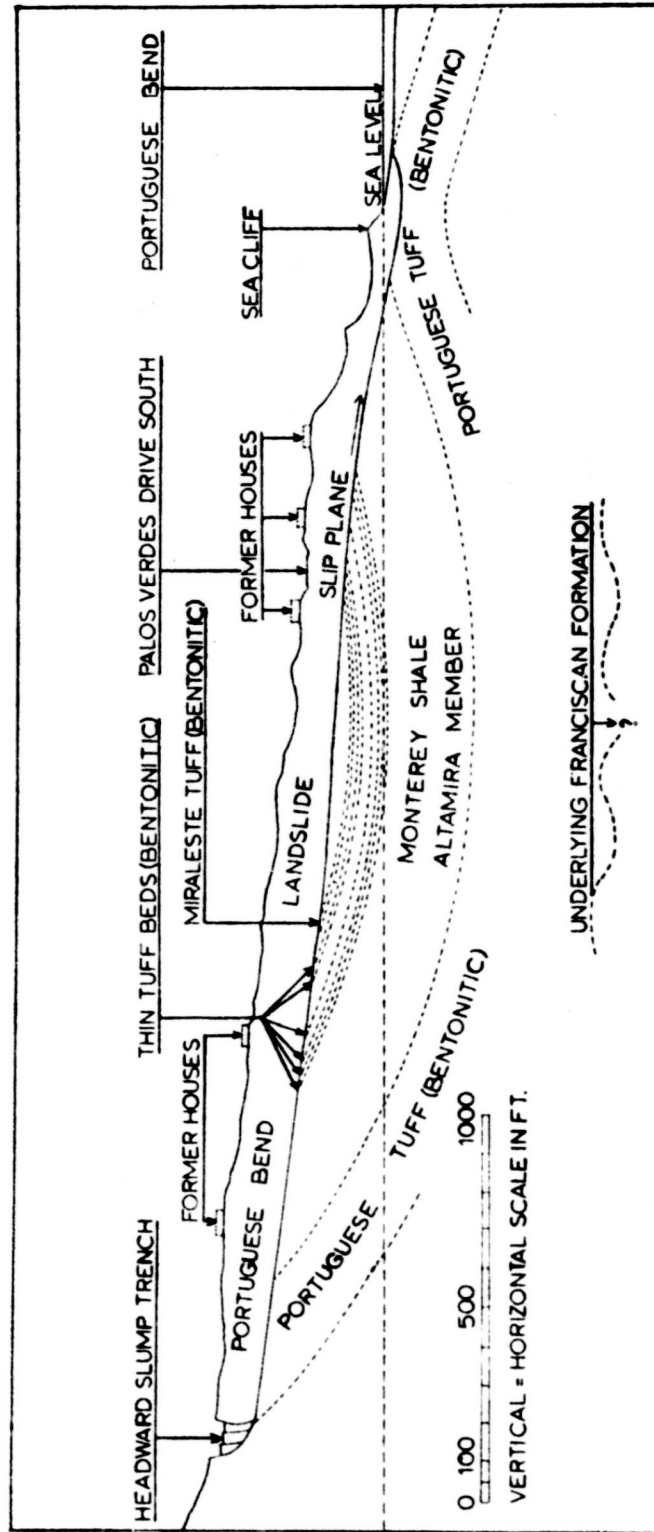
Fig. 3. An approximate structural interpretation of the Portuguese Bend landslide.

A cross section of the Portuguese Bend landslide is shown in Figure 3. It is based on stratigraphic data by Woodring and others (1946, p. 20-21), their geologic map (1946, Pl. 1), subsurface contours of the slip plane, by Stone Geological Associates, and geological observations on several occasions in connection with this study. The structure as projected beneath the slip plane is largely schematic, based on the interpretation by Woodring and others of a structural basin beneath the landslide.

The dip of the slip plane is south, aside from a concave depression beneath the sea-cliff where it extends below sea level and emerges off shore. Mud apparently extruded from the Portuguese Tuff on the ocean's floor stains the water near an abandoned pleasure pier (Pl. 2, Fig.2). No attempt has been made to distinguish the bentonitic from the non-bentonitic portions of the tuff. However, bentonite is restricted to tuff, although much less abundant than the replaced volcanic ejecta. Never-the-less, the accumulation of moist bentonite along the slip plane as indicated by borings is believed to be adequate to provide a lubricated surface for movement as suggested by physical tests.

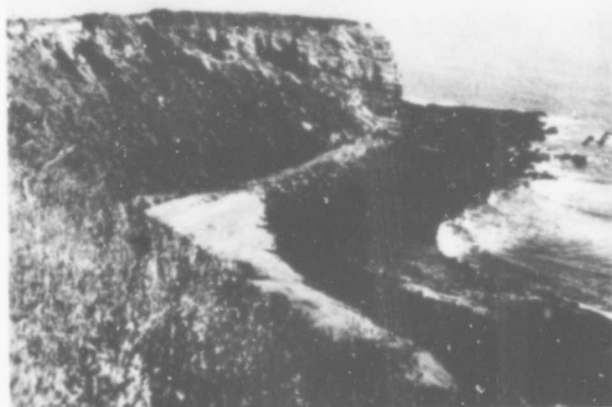
Fig. 1

The Monterey Shale where free from bentonite and even where intruded by basalt appears to form resistant masses not subject to slide action. This resistance is shown by Inspiration Point (Pl. 2, Fig. 1) and Portuguese Point (Fig. 1) which has long withstood extensive marine erosion.

Fig. 1: The stable cliff of Inspiration Point, looking east. Resistant outcrops of Monterey Shale appear on the sea-cliff and along the seashore. Fig. 2: Slide area south of Inspiration Point. Tilted tennis courts and an abandoned pier appear in the foreground. Fig. 3: Fissure in slide area near Inspiration Point. The fissure is about 20 feet deep. Fig. 4: Pond between parallel fissures at head of Peppertree Lane (August, 1966). Water from fault lines would be expected to increase the mobility of bentonite along buried slip planes.

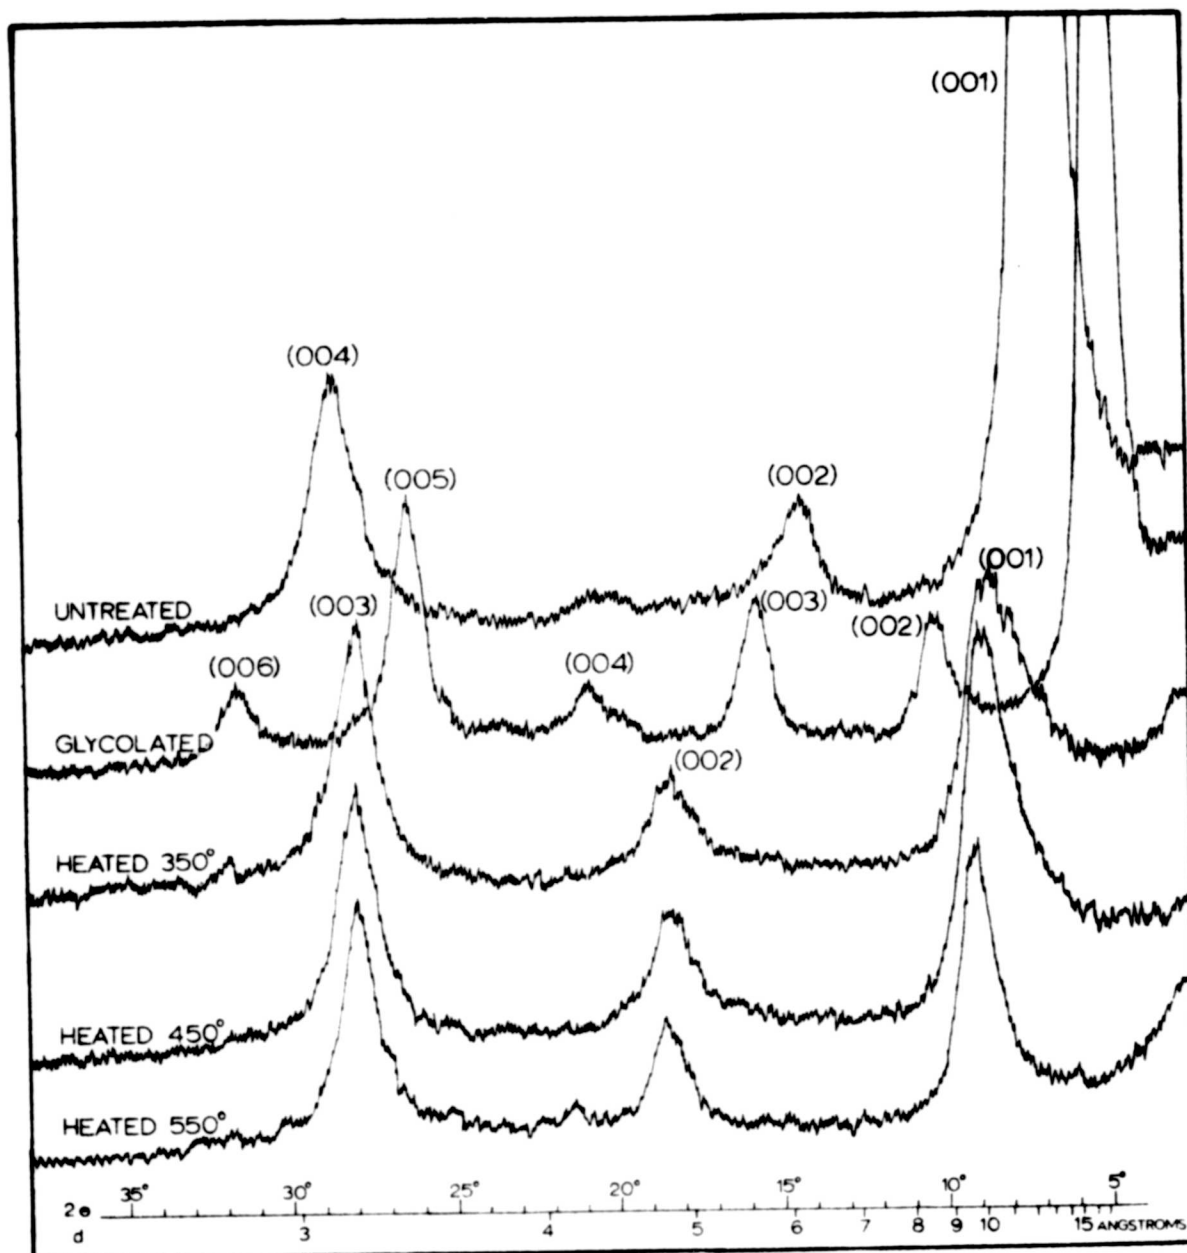
Fig. 4 X-ray diffractometer patterns of monotrillonite in $2\ \mu$ fraction of Sample 2. The (001) reflection expands 14 Å to 17 Å on glycolation. The structure collapses reversibly to 10 Å at temperatures as low as 350°C but irreversible collapse is not encountered until 550°C, when the montmorillonite anhydride or illitic structure is formed.

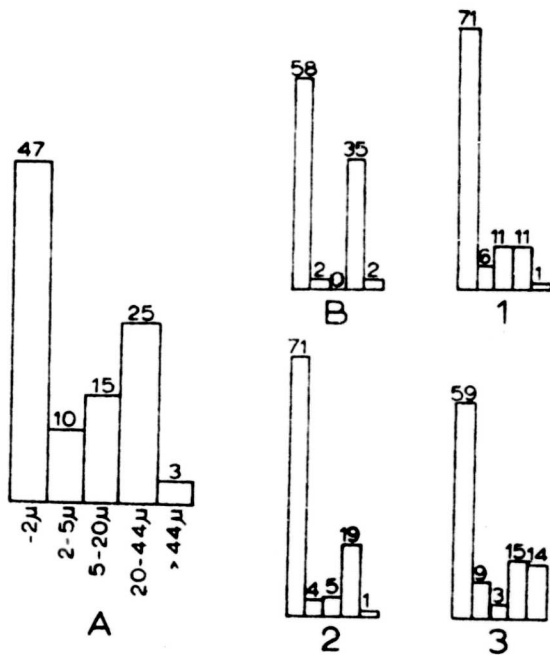
(minus -2μ) material. Sample A, from a road cut to the east of the active slide area, probably from the Portuguese Tuff Bed, contains considerably less fine clay (47 per cent). The particle size distribution curve shows this sample to vary from the others in being well-graded rather than gap-graded (Fig. 6).

Fig. 5 Histograms showing particle-size distributions in Palos Verdes bentonites. Note that Sample A, from outside the slide area, contains the smallest amount of clay-sized material.

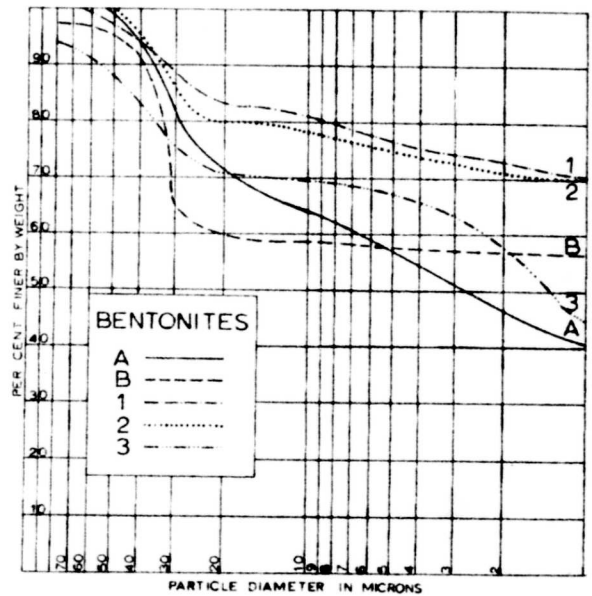
Fig. 6 Particle size distribution curves for the Palos Verdes bentonites. Most of these are gap-graded, consisting mostly of colloidal material and a few per cent coarser tuff particles.

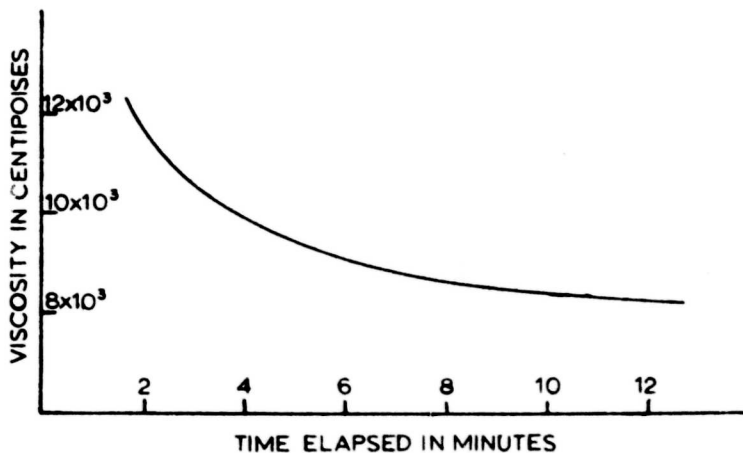
Fig. 7 Decrease in viscosity with time as the thixotropic gel breaks down.

The Palos Verdes bentonite is highly thixotropic. When the viscosity of the minus-2 μ clay fraction is plotted against the time elapsed, it is seen that the viscosity decreases as the system is subjected to constant shearing (Fig. 7). This is typical of thixotropic gels. The colloidal structure is almost completely destroyed in the bentonite after about 10 minutes at a rate of shear of 0.5 RPM.

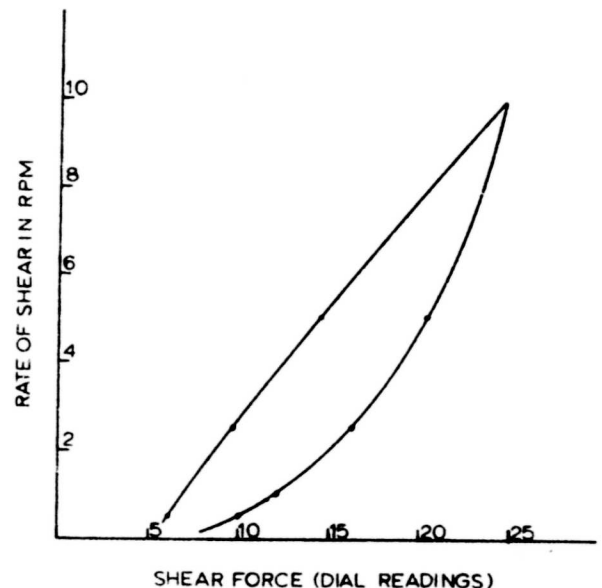
Fig. 8 Hysteresis Loop obtained for Palos Verdes clay.

When the rate of shear was increased from 0.5 to 10 RPM and then decreased again, a hysteresis loop (Fig. 8) was obtained, illustrating the fact that, in thixotropic clays, the shear force, (and viscosity) at any given rate of shear is dependent on the amount of previous shear the system has undergone. Shearing causes breakdown of the particle links in the skeleton structure of the more or less flocculated clay-water system, thus reducing the viscosity of sheared clays.

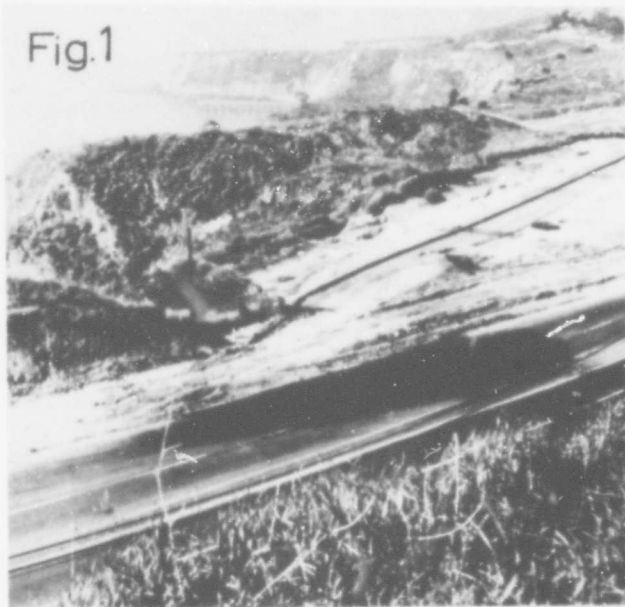
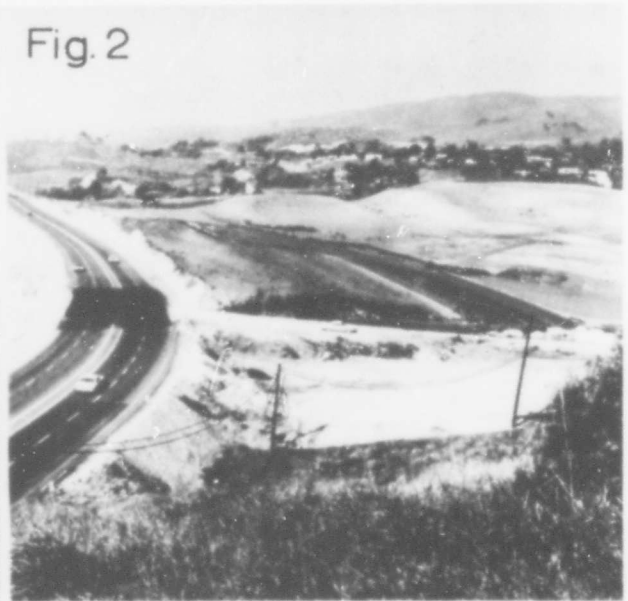
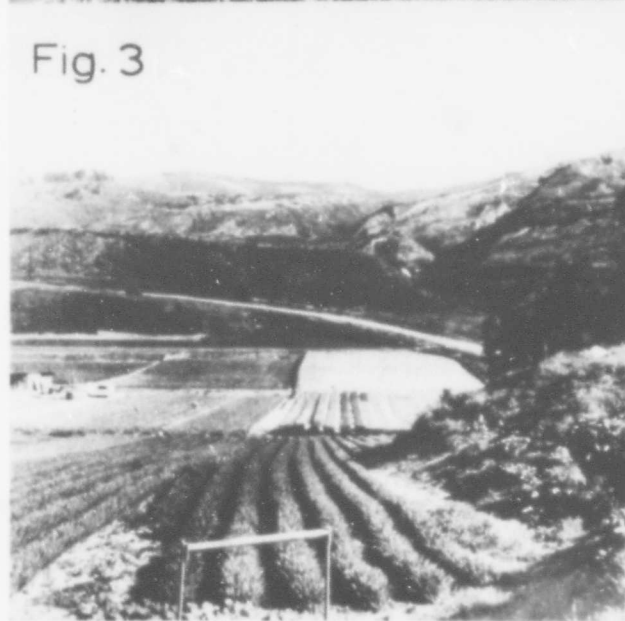
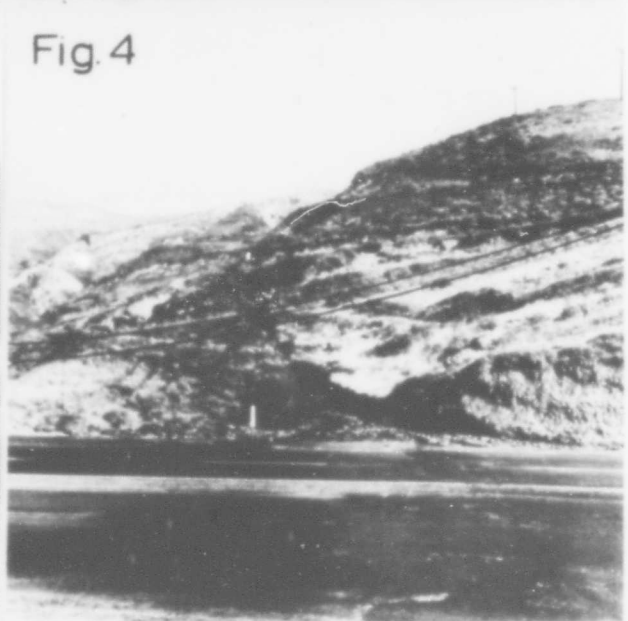
Plate 3. Physiographic Features of the Portuguese Bend Landslide.

Present movement south of Palos Verdes Drive (Pl. 3, Fig. 3) consists of slow earth movement in which crushed debris and bentonite undergo plastic flow. North of the drive, larger blocks may move fairly intact (Pl. 3, Fig. 2), but are shifted relative to one another and in places exhibit marginal fissures. At the head of the slide, block rotation may be observed (Pl. 2, Fig. 2). A cyclic variation in slide movement can be correlated to precipitation with a lag of several months between rainfall and slippage (Merriam, 1960).

Fig. 1: Recently relocated (Feb. 1967) portion of Palos Verdes Drive South looking southwest at east margin of slide. Note service pipe on surface crossing former highway area. Fig. 2: Marine terrace tilted inland by slide rotation. Looking west along Palos Verdes Drive South at east margin of slide area. Fig. 3: Looking north across carnation nursery in area depressed by slide action. Fig. 4: Looking north at the scarp along the east margin of slide area north of Palos Verdes Drive South.

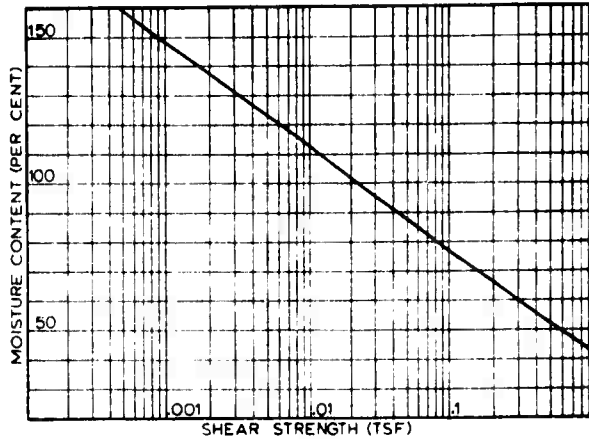
Water content has a great effect on the properties of the Palos Verdes bentonite. As can be seen from Fig. 9, doubling the moisture content decreases the unconfined shear strength by more than 10 times. At the moisture content measured for the Palos Verdes clay, shear strengths would be on the order of only $1/4$ ton per square foot.

Fig. 9 Influence of water content on shear strength, as measured with Swedish Cone.

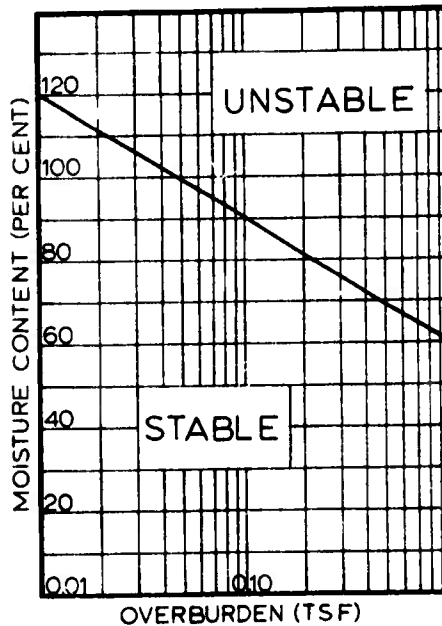
An experiment was devised in order to study the influence of water content and overburden pressure on the stability of the clay strata at Portuguese Bend. A layer of bentonite $1/2$ -inch thick was spread between two rigid boards and the system adjusted to a constant slope of 1:10. The water content of the clay stratum was changed by the addition of increments of distilled water. The exact water content was measured after each test by oven drying and weighing samples of the clay. Loading of the upper board was also varied. Clay flowage was measured by timing the relative movement of vertical marks on the boards. The results of this experiment are illustrated in Fig. 10. At moisture contents greater than 120 per cent, the clay exhibited a slow plastic flow without loading. Loads selected would cover a range of about 0 to 150 feet, the estimated thickness of material above the slip plane at Portuguese Bend. As the load was increased, the water content at which the clay would show movement within a 24 hour period decreased. In this way, regions of stability and instability could be identified. Although an artificial model, this experiment is at least suggestive in considering movement of rock masses on moist clay under the field conditions at Portuguese Bend.

Fig 10 Graph illustrating influence of water content and overburden pressure on the stability of Palos Verdes bentonite. The greater the overburden pressure, the lower the water content necessary to produce movement.
